Practical Application of Crumb Rubber Concrete in Residential Slabs

Osama Youssf^{a,c,*}, Julie E. Mills^a, Mark Ellis^a, Tom Benn^a, Yan Zhuge^a, Xing Ma^a,
Rebecca J Gravina^b

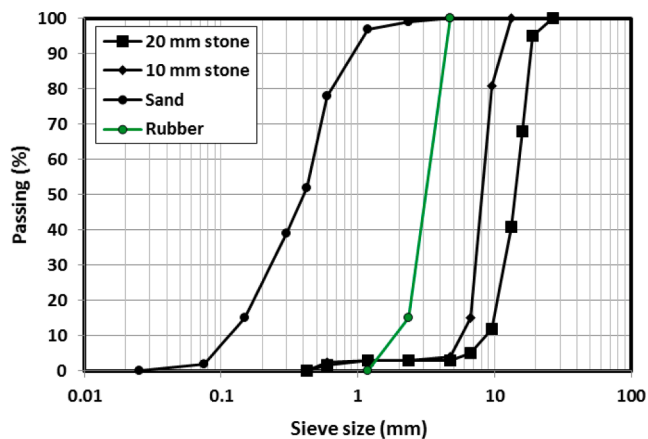
Fig. 1. Particle distributions of the aggregates used.

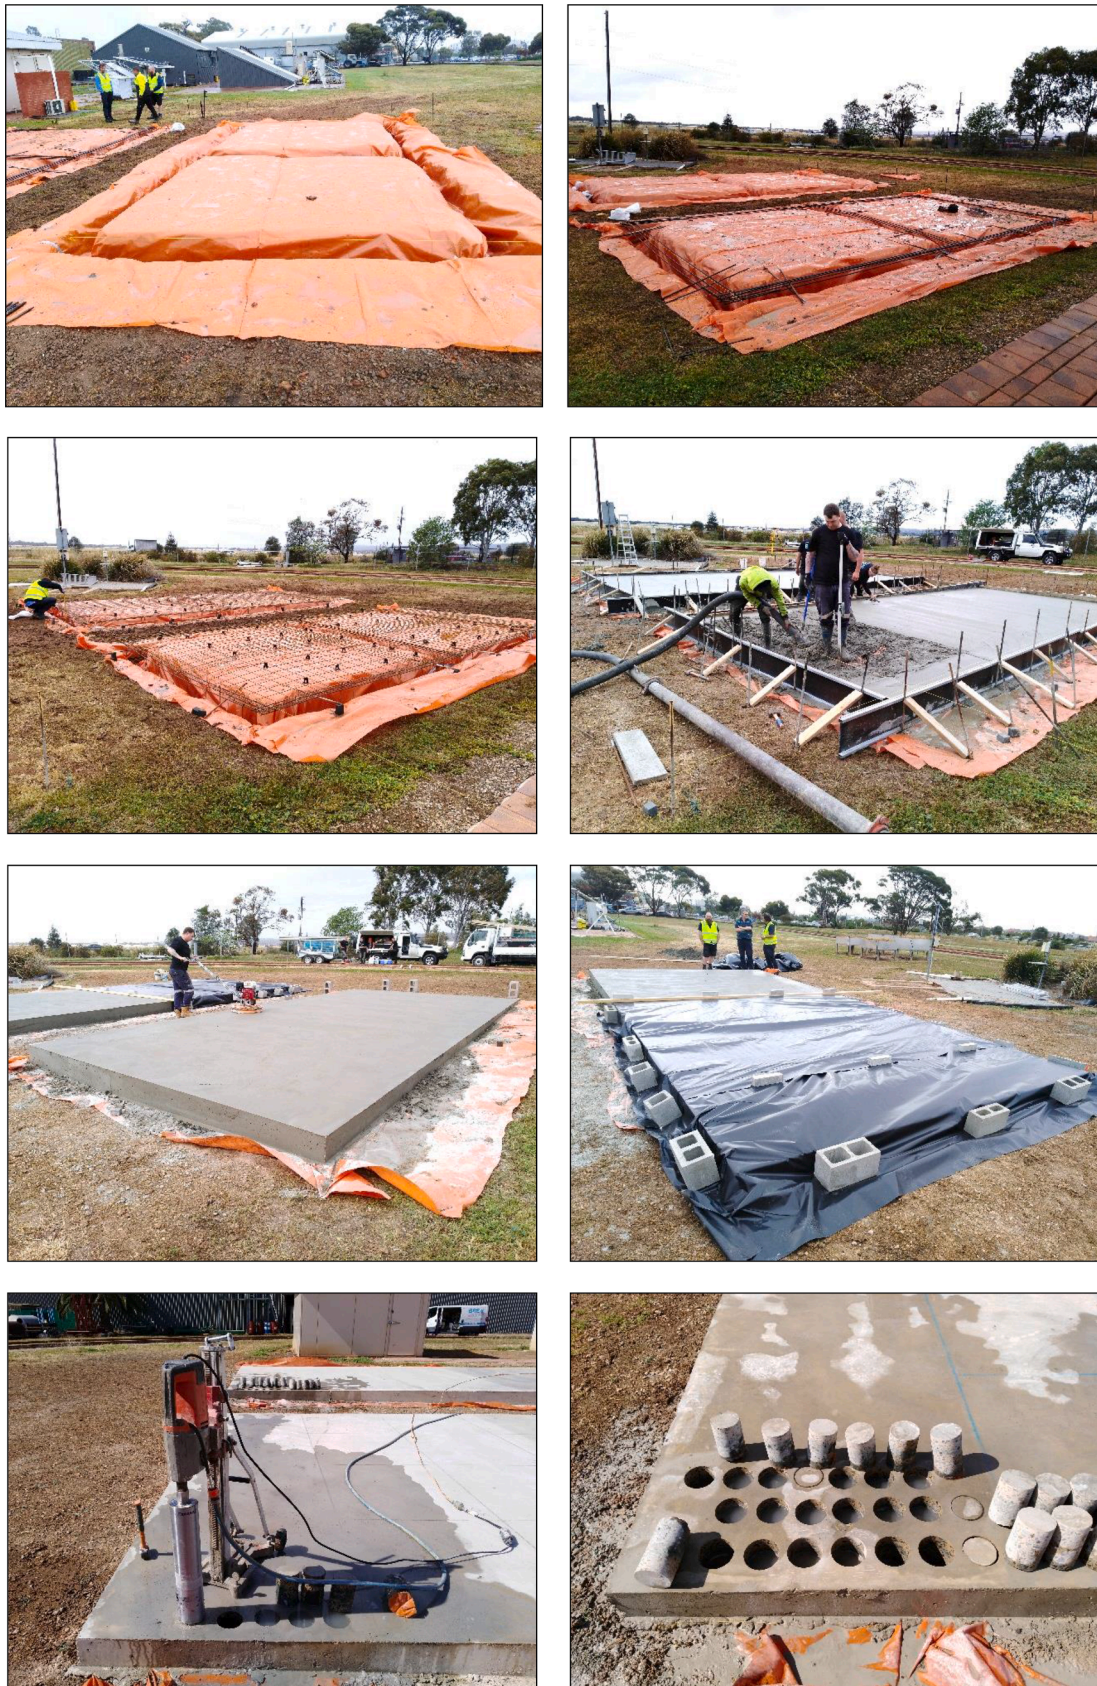
Fig. 3. Residential slab casting, curing, and coring.

industry). The soil type at the construction site was a reactive clay/silty clay, classified as H1-D with a maximum surface movement, $y_s = 47$ mm. The area is known for the salinity and relatively aggressive nature of its soils. The footing was designed by a consulting engineering company with a significant market share in the residential footing industry in South Australia. Fig. 3 shows the procedures of slab casting, curing, and coring.

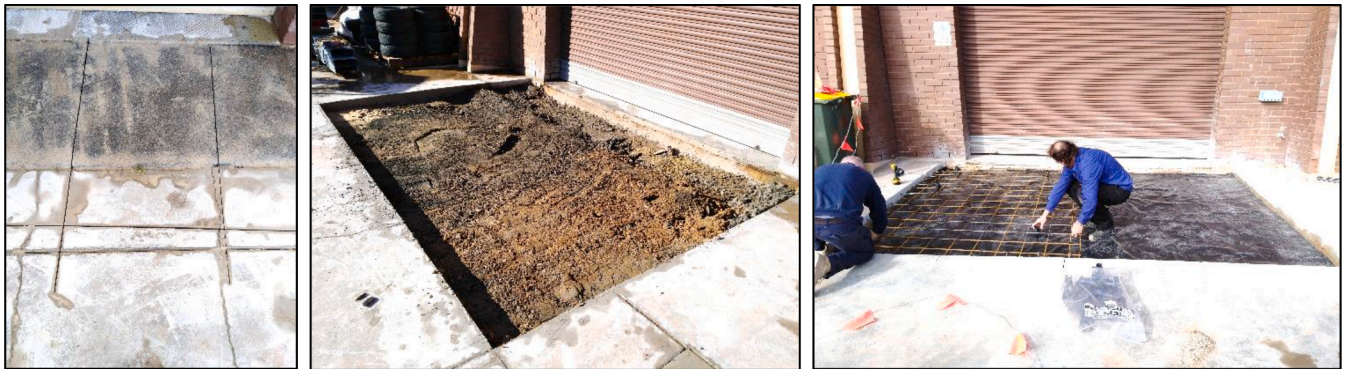
Fig. 5. Removing old ground slab and preparing for new replacement.

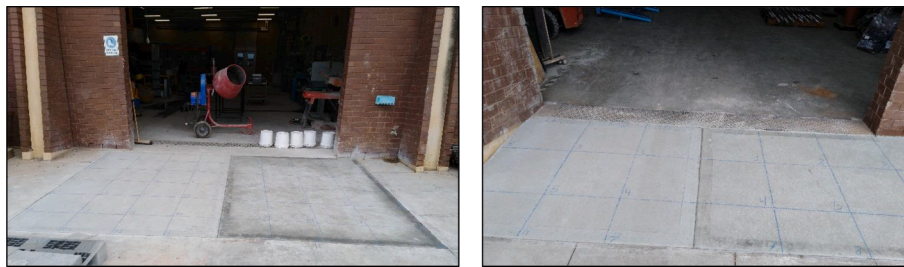
Fig. 6. The ground slab after casting and surface finishing.

Two ground slabs were also poured at two vehicle entrances of the civil engineering laboratory at the University of South Australia. These laboratory entrances experience high traffic loads of heavy vehicles including; fork-lift, light utility vehicle, and heavy trollies. One slab had dimensions of 3.6 × 2.9 m and the other one had dimensions of 3.1 × 1.4 m, as shown in Fig. 4. These slabs replaced old deteriorated conventional concrete slabs that were removed using a concrete saw. The base soil underneath the slabs was mixed with demolished concrete rubble and then compacted and isolated using plastic sheets, as shown in Fig. 5. At each entrance, the eastern half of the slab was poured using rubberised concrete CC32R and the western half of the slab was poured using conventional concrete CC32. The slab thickness was 125 mm and they were reinforced by square reinforcing mesh having 9.5 mm diameter bars with 200 mm spacing in both directions. The surfaces of the ground slabs were roughly finished using a broom, while the slab edges were smoothly finished with 4-inch steel edger. All ground slabs were left for air curing. Fig. 6 shows the ground slabs after casting and surface finishing.

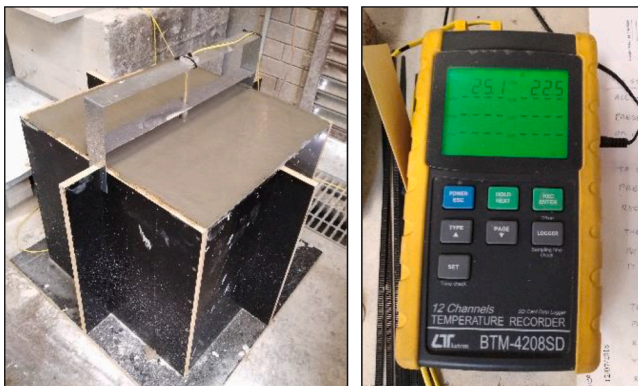
Fig. 7. Recording of hydration temperature.

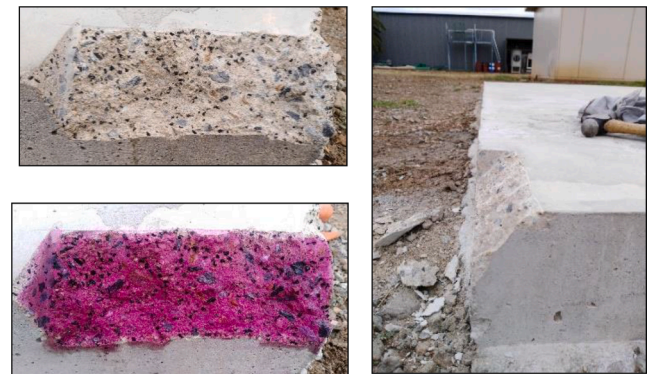
Fig. 8. Normal carbonation depth measurement.

The carbonation development in the slab was measured by cutting a 70×200 mm fresh piece of concrete from the slab cantilever edge and spraying indicator (phenolphthalein 0.5% solution in 50% ethanol) to determine the carbon dioxide (CO_2) depth, as shown in Fig. 8. The fresh concrete cut was taken from the slab edge to check the CO_2 penetration from both slab sides exposed to the air (top surface and vertical side).

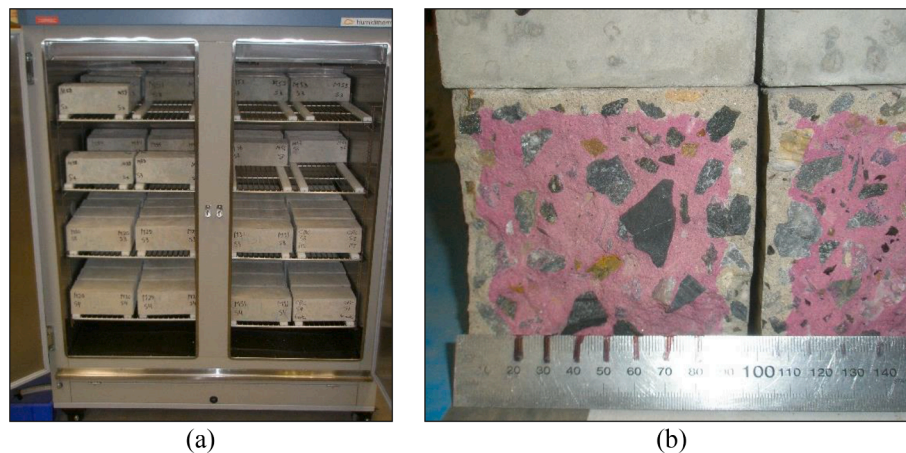
Fig. 9. Accelerated carbon dioxide ingress; (a) specimens in environmental chamber, and (b) measuring of carbonation depth.

Concrete specimens were cast to undertake accelerated carbon dioxide ingress testing of the concrete used for the slab construction in accordance with the recommendations of Zhou and Papworth [46]. Four $100 \times 100 \times 250$ mm prisms were cast for both the CC and CC20R mixes. The prisms were cast in a vertical position (similar to a standard concrete cylinder) to minimise concrete segregation. Approximately 24 h after the prisms were cast, they were carefully removed from the moulds and placed in a lime bath for another 6 days. After this time, the prisms were removed and allowed to air cure for a further 21 days in accordance with the recommendations of Zhou and Papworth [46]. Each prism was placed on a drying rack with timber supports at each end of the prism to ensure full curing of all the prism faces. Care was taken to avoid handling the middle section of the prism as this is where the carbon dioxide ingress would be measured. All four prisms were then placed into the environmental chamber with plastic supports at each end of the prism, see Fig. 9(a). This allowed the carbon dioxide to fully circulate around the prisms. The environmental chamber was set to a temperature of 23 ± 3 °C, relative humidity of $65 \pm 5\%$, and carbon

After 28 days, one prism was removed from the chamber and split in two halves using a three-point bending testing machine. The exposed surface of each half was then sprayed with phenolphthalein indicator (same mixture as used for the residential slabs). The sprayed indicator was allowed to dry, and the depth of carbonation ingress measured on all four faces for both halves of the prism at 10 mm intervals. The first measurement was taken at distance of 20 mm away from the corner to avoid any edge effects, see Fig. 9(b). This procedure was repeated at 56, 119, and 182 days of concrete age for the other three prepared prisms.

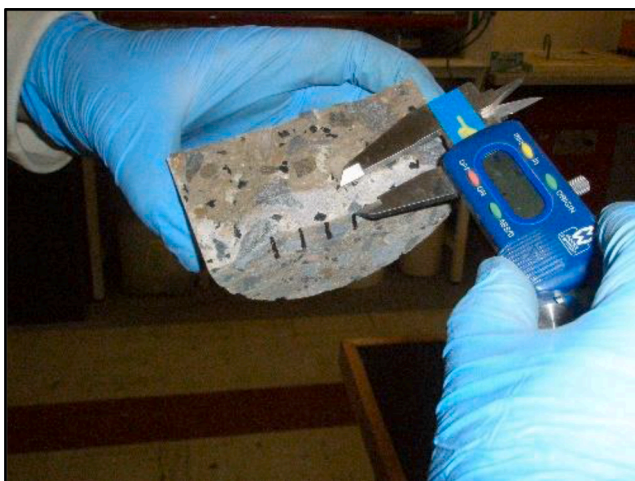
Fig. 10. Determination of the chloride ingress depth.

for a duration of 24 h. After the test had finished, the test specimens were removed from the test setup and split into two halves using a splitting tensile test machine. The exposed surface of the flatter half was painted with silver nitrate (AgNO_3) solution (in accordance with the test method) and the depth of the chloride ingress was determined at various locations across the width of the specimen, see Fig. 10. The outer 20 mm were excluded from the measurements to avoid edge contamination.

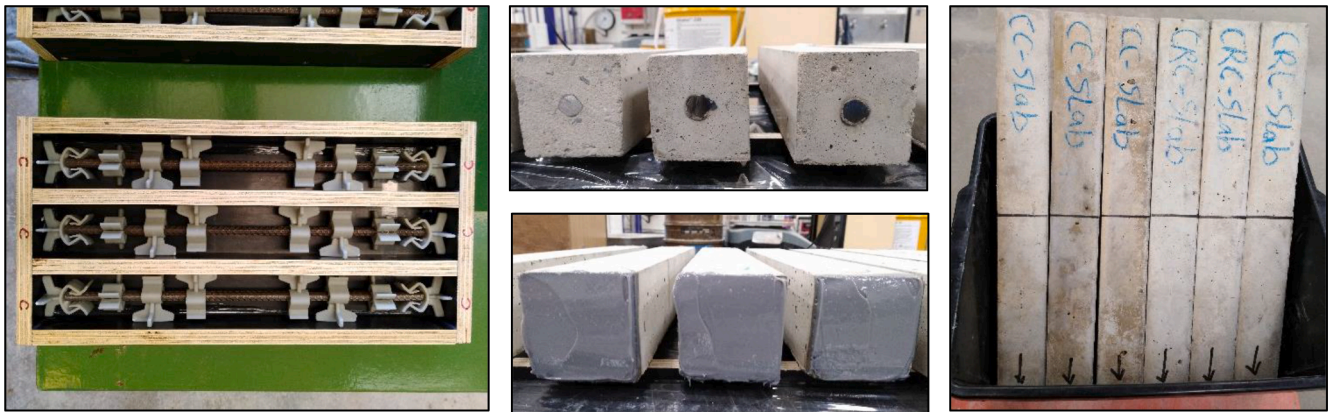
Fig. 12. Dampness and corrosion development beams and test setup.

Long term dampness and corrosion development was measured using $60 \times 60 \times 470$ mm beams with a deformed bar centrally embedded in each beam. In total, eighteen beams of each mix were cast; half had N10 steel bar centred using plastic chairs to keep 25 mm cover constant from all bar sides including the bar ends. However, in the other half of the beams, the N12 steel bar was centred using wooden formwork with holes in which the bar went along the whole concrete beam length with 20 mm projection from each end. The bars were then trimmed at the beam edge surfaces and the beam edges were covered by two-part waterproof epoxy to isolate the steel bar from water at the beam edges. Fig. 12 shows the preparation of the dampness and corrosion beams. The eighteen beams of each mix were divided into three sets of six beams (three with N10 and three with N12). These three beam sets were tested in three different environments/conditions. One set was embedded to a depth of half their length close to the residential slabs (clay/silty soil). The second set was buried to half their length in a highly saline sandy soil in the Port Adelaide area (South Australia). The third set was fully soaked in 5% sodium sulphate solution. This resulted in twelve beams (six of each mix) in each testing environments/conditions. The beams were secured in an upright position using horizontal square reinforcing mesh welded to four legs of long reinforcing bar that were embedded into the soil as shown in Fig. 13. The concrete dampness was measured by visually investigating the outer surfaces of the beams. The reinforcement steel corrosion development was measured by determining the mass loss in the embedded bars due to corrosion according to ASTM G1-03 [50]. Each reinforcement bar was cleaned of the corrosion products using 12% hydrochloric acid (density of 1.19 gm/cm^3) solution after demolishing the surrounding concrete according to ASTM G1-03 [50]. The cleaning process commenced by removing the corrosion products initially by using a hammer and steel brush, then by chemically soaking the bars in the HCl solution for 25 min at 23°C . The bars were then washed with distilled water by lightly brushing the corrosion products using a non-metallic brush. The cleaned bars were oven dried at 50°C for 30 min before measuring the mass loss.

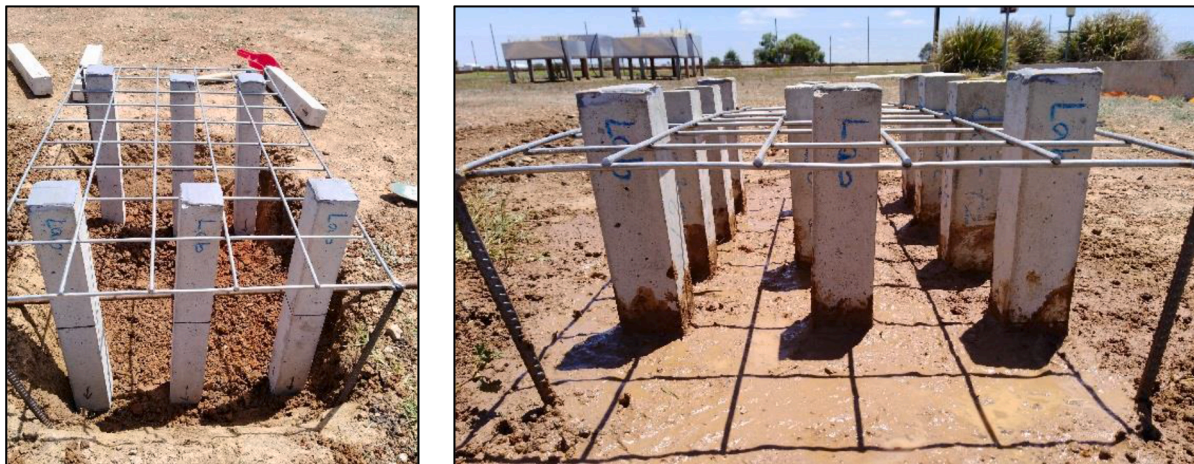
Fig. 13. Dampness and corrosion development beams buried.

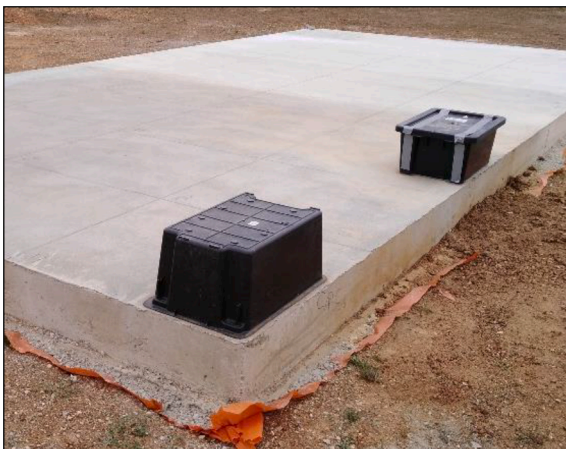
Fig. 14. Edge dampness test setup.

The edge dampness development was measured by covering a 400×600 mm surface area of concrete slab surface at its southern edge using a plastic tub (250 mm depth) with small openings in the side walls of the tub to keep the covered area dry at all times. This experimental setup was done at two locations in each footing slab. At the first location, the plastic membrane laid by the contractor underneath the slab and the

beam sides before concrete pouring, was kept in place (isolated concrete edge). However, in the other location, that plastic membrane was manually removed from beneath the slab/beam side for the whole depth and 1 m width (naked concrete edge) to ensure full contact between the concrete and the soil to increase the edge dampness effect. Fig. 14 shows the locations of the edge dampness test setup.

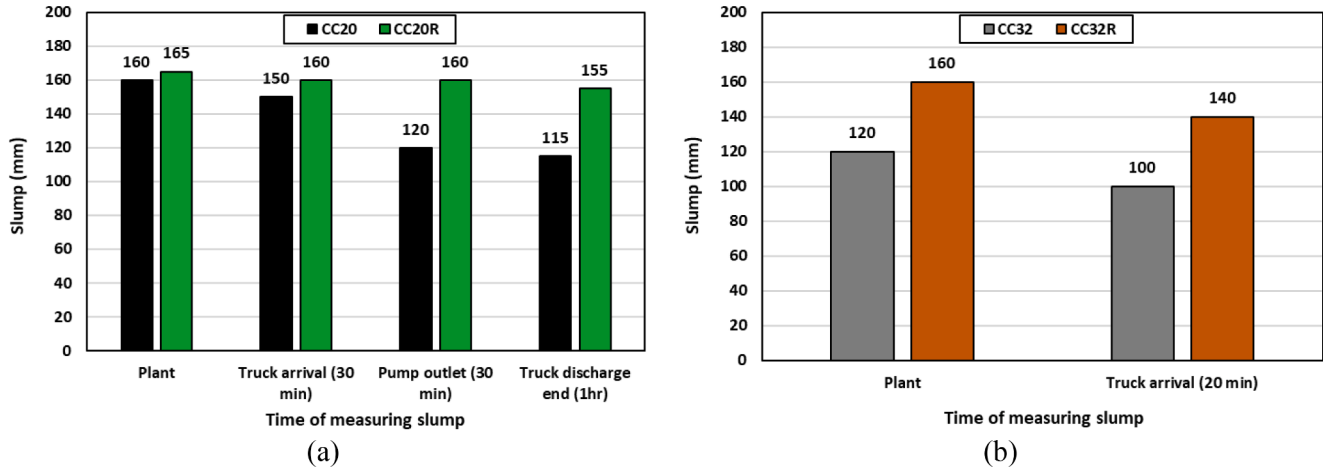
Fig. 15. Slump losses of the mixes used; (a) CC20 and CC20R, (b) CC32 and CC32R.

Fig. 15 shows the concrete slump losses with time for all mixes. About 1 h after completing the mixing, the CC20R mix had a negligible decrease in slump of only 10 mm (6%), compared with relatively higher slump losses of 45 mm (28%) recorded for mix CC20. This was attributed to the lower rate of water absorption and hydrophobic nature of the rubber aggregates with the size used in this study (1.18–2.36 mm) compared to that of the replaced sand, thus keeping the concrete mix at a higher moisture content for a longer time. This was explained by Youssf et al. [40] in which the rubber size controls its water absorption and hence governs the concrete slump. They showed that the rubber sizes of 0.15–0.425 mm and 0.3–0.6 mm adversely affect the concrete slump; however, sizes of 0.6–1.18 mm and 1.18–2.36 mm increase the concrete slump. The slump losses recorded for all mixes at the time of the truck’s arrival at the construction site was not significant and did not cause any issue for the contractor when they handled and finished the concrete. However, it was more pronounced in the 32 MPa concrete mixes. At the time of the truck’s arrival, the slump losses were 16% and 12% for CC32 and CC32R mixes, respectively, and were 6% and 3% for CC20 and CC20R mixes, respectively. This was due to the relatively low water content and the existence of the fly-ash in the 32 MPa concrete mixes.

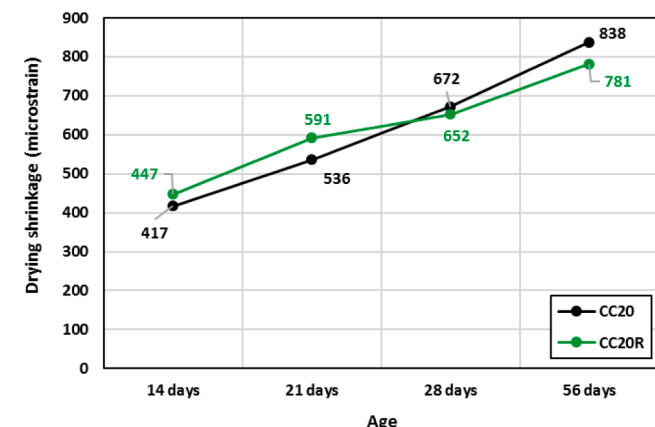
Fig. 17. Drying shrinkage for footing slab mixes.

Fig. 17 shows the measured drying shrinkage for the concrete footing slab mixes (CC20 and CC20R) at different concrete ages. As shown in the figure, the concrete drying shrinkage increased with concrete age due to the evaporation of water from concrete with time. CRC showed similar shrinkage values to that of the counterpart CC at all ages, with slightly lower long-term values. This was attributed to the hydrophobic nature of rubber particles that repel water and caused no significant effect on the water transfer within the concrete matrix while drying. The differences between the measured shrinkage for both CC20 and CC20R ranged between only 3% and 10%. Therefore, using rubber in concrete has an overall insignificant effect on the concrete shrinkage.

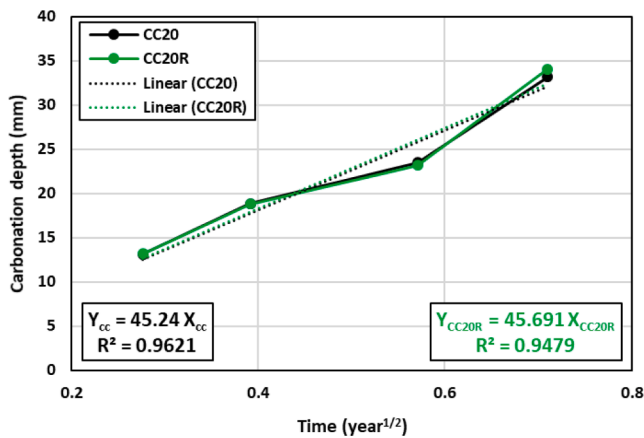
Fig. 20. Accelerated Carbonation Rate for footing slabs mixes.

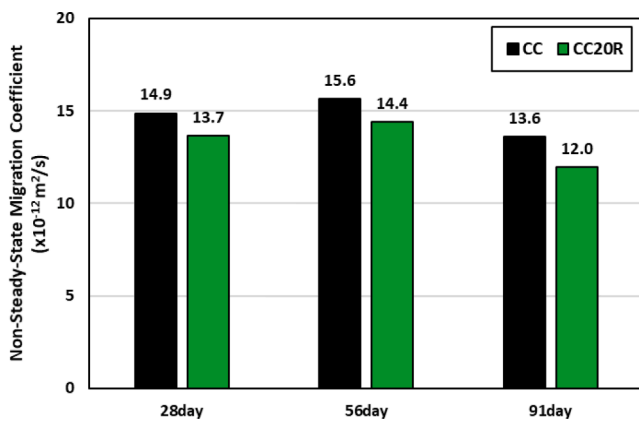
Fig. 21. Chloride ingress at different ages.

the cored specimens and according to Eq. (1). The average test results are shown in Fig. 21. For both CC and CCR20, D_{nssm} increased slightly between 28 and 56 days then decreased again at 91 days to a result lower than at 28 days. This trend may be due to the very dry weather that the slabs experienced for the first two months after being poured, preventing both slabs from fully curing. Importantly, D_{nssm} was lower for CC20R than CC at all ages. This indicates that rubber does not have an adverse effect on concrete resistance to chloride ingress and could reduce the chloride ingress by about 10%. Chloride ingress is largely influenced by the water/cement ratio and the aggregate volume fraction ratio [56]. As the rubber has a larger size than the replaced sand, the effective aggregate volume fraction would increase slightly in the rubberised concrete reducing the overall chloride migration coefficient.

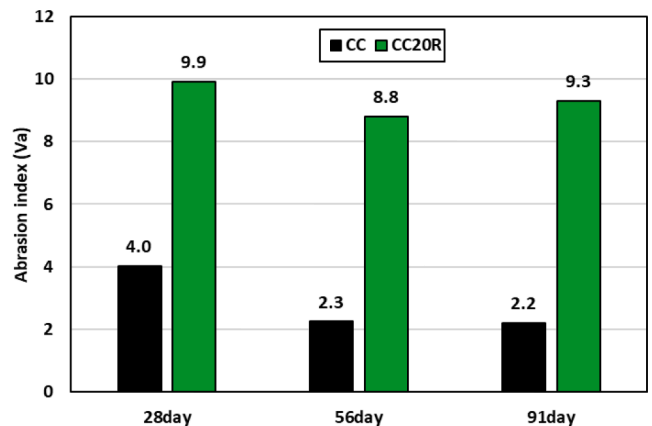
Fig. 22. Abrasion index at different ages.

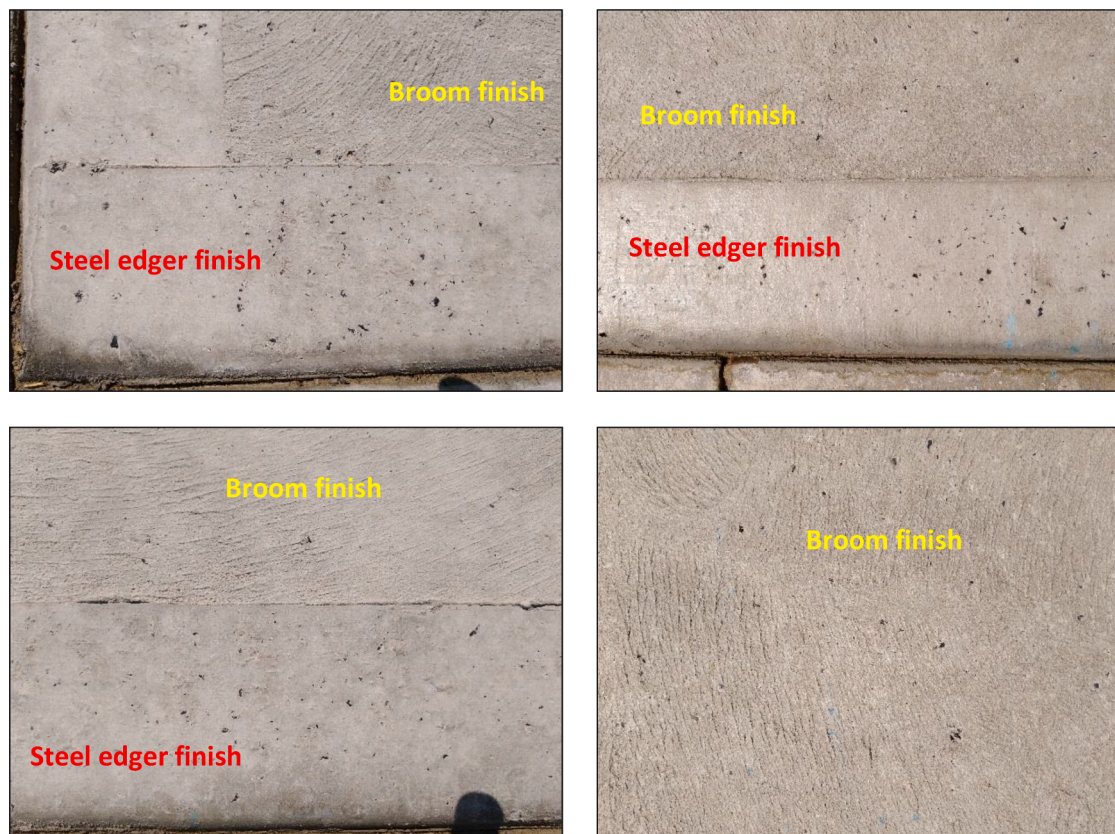
Fig. 23. Surface of CRC ground slabs at different locations.

The concrete surfaces of both residential footings slabs and ground slabs were monitored to report any visual deterioration and cracking with time. As observed in the CC, no visual deterioration or cracking was detected on the CRC surface up to 18 months for the residential footing slabs that were surface finished by the power trowel method. For the ground slabs, outside the laboratory, observations up to 15 months showed no adverse effect of using rubber in the concrete generally. Only some minor voids were observed on the surface of the CRC ground slabs at the perimeters that were smoothly finished by a steel edger, as shown in Fig. 23. This was due to the bad adhesion between rubber particles and cement paste which caused easy detaching of the rubber particles leaving some surface voids. However, this was much lower in the surfaces that were roughly finished using a broom. The rough CRC surface finishing might provide better containment of the rubber particles at the surface which increased its adhesion to concrete. Therefore, it is recommended to avoid smooth surface finishing of CRC when utilising it in ground slabs subject to high traffic of vehicles and walkers. These observations also demonstrated that from a practical perspective, there was no concern with abrasion of the ground slabs and that this test was more realistic and useful than the standard ball bearing abrasion test in predicting the actual behaviour of the CRC from a surface wearing perspective.

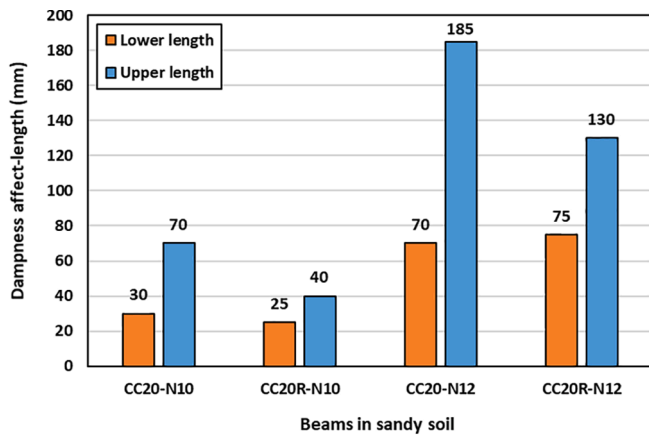
Fig. 26. Dampness effect – sandy soil.

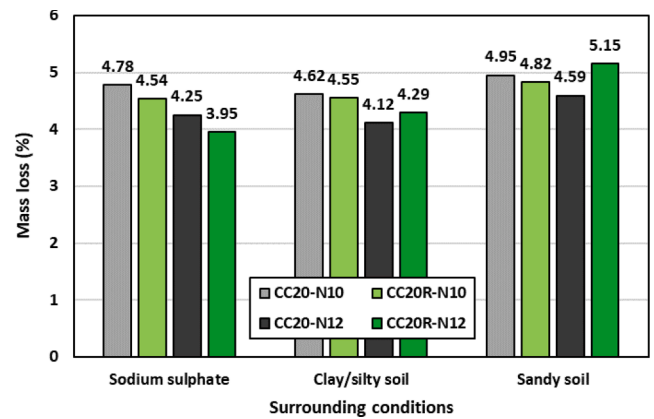
Fig. 27. Mass loss due to corrosion.

The mass loss in the embedded bars due to corrosion is shown in Fig. 27. Small mass loss values ranging between 3.95% and 5.15% were recorded in all beams under different conditions. The average mass loss in both N10 and N12 bars for beams buried in sandy soil were higher than those in clay/silty soil and sodium sulphate solution. The average mass loss in CC20R-N10 beams was 3% less than that in CC20-N10 beams; however, it was 3% higher in CC20R-N12 beams compared with that in CC20-N12 beams. For beams soaked in sodium sulphate solution, CCR20 beams had 5–7% less mass loss in both N10 and N12

bars than was recorded by the corresponding CC20 beams. For beams buried in clay/silty soil, CCR20 beams showed only 1.5% less mass loss in N10 bars, but 4% higher mass loss in N12 bars. For beams buried in sandy soil, CCR20 beams showed only 2.6% less mass loss in N10 bars, but 12% higher mass loss in N12 bars. From the above results, it can be concluded that CRC performs similarly to CC in resisting steel reinforcement corrosion as no significant difference was observed.
